Thompson Sub-basin Plan

City of Sammamish

Parametrix

City of Sammamish. 2011. Thompson Sub-basin Plan.
Prepared by Parametrix, Bellevue, Washington,
in association with WindWard Environmental,
Seattle, Washington. September 2011.

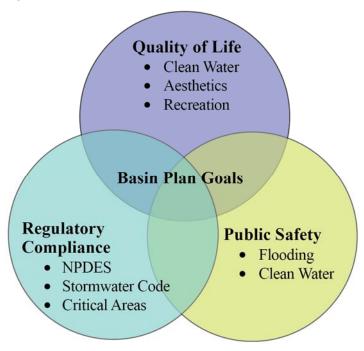
Figure 2. Basin Plan Framework

These City goals, as well as regulatory directives, such as the City's National Pollutant Discharge Elimination System (NPDES) Phase II permit, and public safety issues such as flooding and access to clean water, provide the framework for development of the Thompson Sub-basin plan (Figure 2).

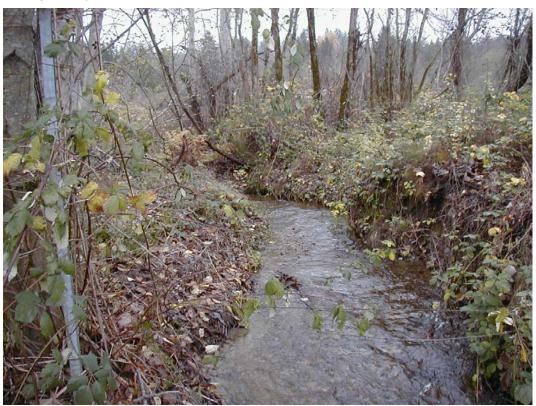
Photograph 1. Typical stream reach in the lower Ebright Creek, just upstream of East Lake Sammamish Parkway, consisting of an extended riffle habitat within a defined channel with few pools, flowing through a moderately functioning riparian corridor.

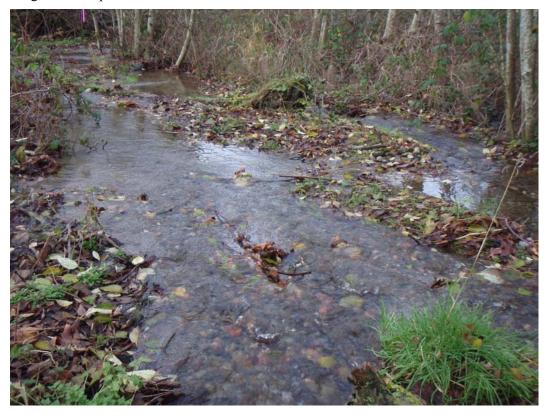
Photograph 2. Area of braided channel in the lower Ebright Creek, located about 0.2 mile upstream from East Lake Sammamish Parkway. The pink ribbon in the background indicates the location of a kokanee spawning redd.

The reach just downstream of the steeper gradient stream reaches (about RM 0.3) showed some accumulations of sediment and stream channel braiding (Photograph 2). Although the Parametrix biologists reviewed historical aerial photographs, they were unable to determine the degree to which the stream channel braiding is a recent development or if this particular reach has been historically braided due to the low gradient in this area. However, the braided area was relatively short (about 300 feet), with the remainder of the stream typically occurring in a well-defined channel. Although this channel braiding has resulted in a wider and shallower stream channel and floodplain (as compared to the majority of the lower stream reach), this area contained about half of the observed or previously identified spawning redds. Therefore, it is uncertain how much the erosion and sedimentation is affecting salmonid production in the stream.

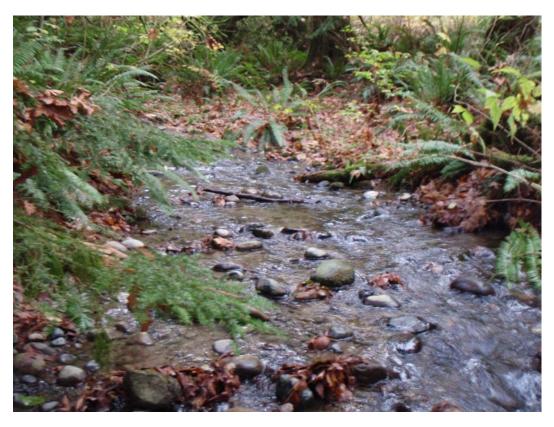
Photograph 3. Typical habitat in the steeper reaches of Ebright Creek, upstream of about RM 0.3.

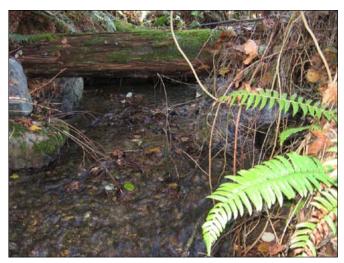
Station 3. Ebright Creek 100 feet upstream from Lake Sammamish.

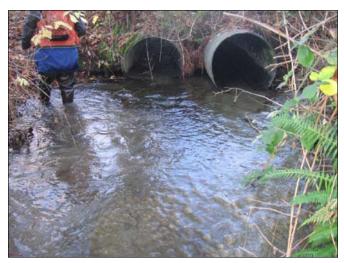
Station 5. Ebright Creek 413 feet upstream from Lake Sammamish at the trail crossing.

conditions would likely deteriorate at both high and low flows. The two 36-inch-diameter culverts under the trail have enough capacity to convey the 100-year flood event, although King County previously identified a CIP to replace these culverts with a bridge to improve fish passage (King County 1994). A detailed fish passage assessment was not included as part of the reconnaissance survey. The two 36-inch-diameter culverts under the parkway are in similar condition. An additional 24-inch-diameter culvert at about RM 0.25 is likely a complete barrier to fish (Ecology 1994), as is the 30-inch-diameter culvert located at SE 12th Street (about RM 1.1).

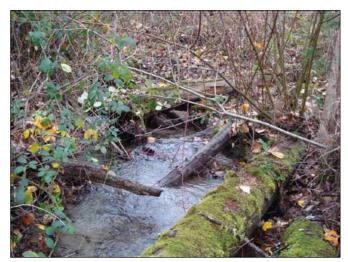
Station 7. Ebright Creek 550 feet upstream from Lake Sammamish.

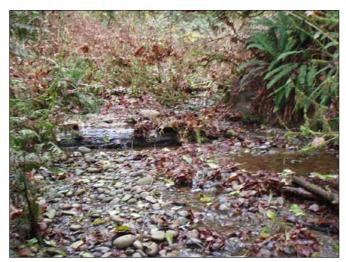
Station 21. Ebright Creek 3775 feet upstream from Lake Sammamish.

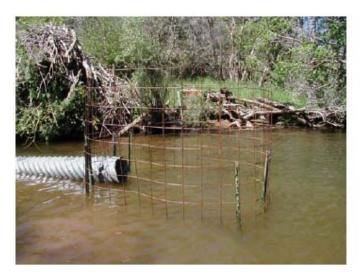
Vertical Cylindrical Wire Mesh Beaver Guard

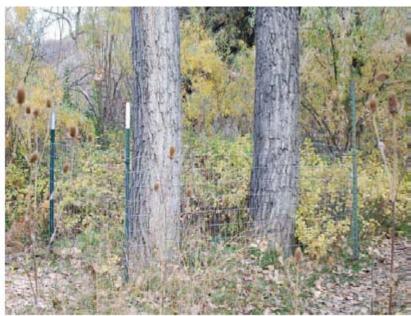
6. **Fencing:** This is a permanent solution for protecting trees from beavers. This alternative consists of loosely wrapping (need room to grow) the important trees with chicken wire or hardware cloth within a riparian zone. The height of the fence only needs to be 3-4 feet. To protect large areas, use the 3-4 foot tall chicken wire or

similar materials. Stake the fence into the ground to prevent the beavers from crawling

beneath the fence. (From Beaver Management Plan)

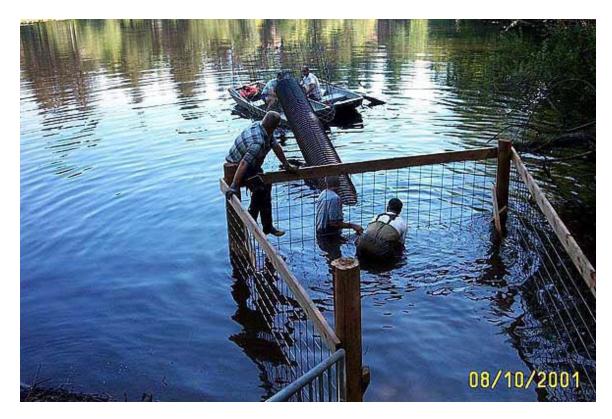
Photo of Beaver Deceiver From Solving Problems with Beavers

Success Data: A wildlife biologist (Skip Lisle) has installed this device at 18 culvert sites over 130,000 acres. Prior to installation, beaver related road maintenance cost was expensive. After installation, road maintenance costs for the past 6 years have been practically non-existent. (Introduction to Non-Lethal Beaver Management) Hundreds of this low maintenance solution are now in place in North America. It's become evident that this alternative maximizes the benefits of the beavers while minimizing the conflicts. (US Beaver Management Tool Crosses the Pond)
